What Went Wrong?

CASE N^o 27

Why were compressor cylinders cracking after many decades of reliable service?

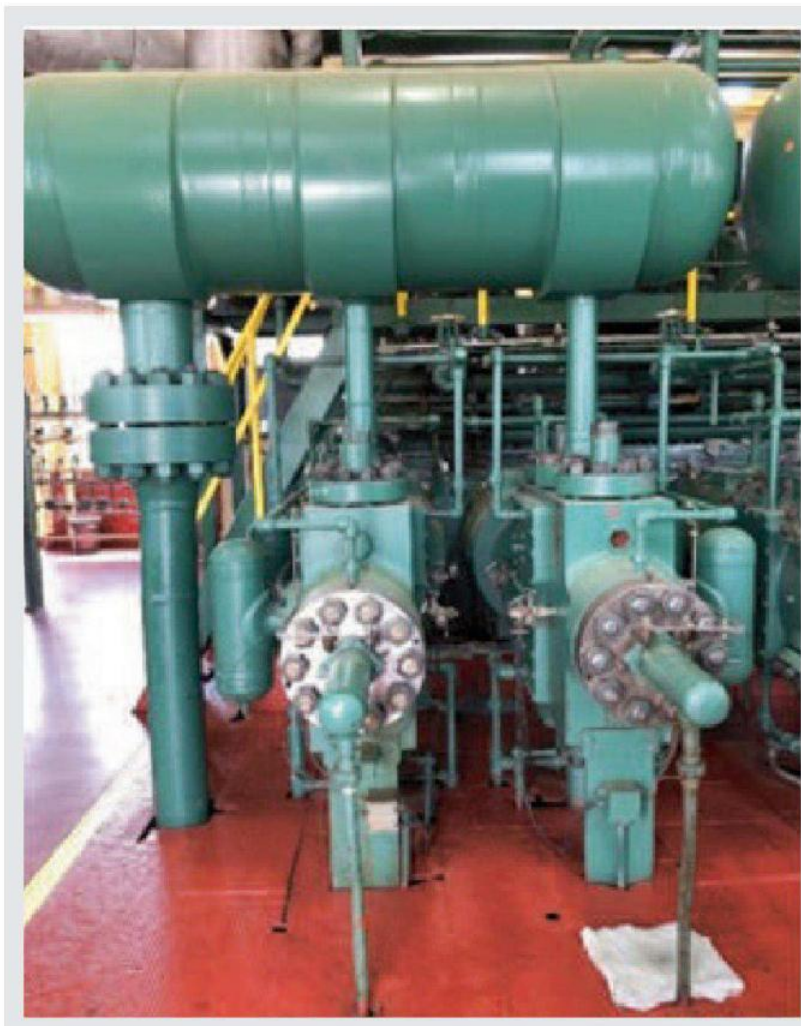
The failed cylinder was one of two 2nd-stage cylinders of the type shown in Figure 1 on a 330-rpm integral engine-compressor. The 15-in. (381-mm), 8.5-in.- (216-mm-) bore diameter, 5000-psig (344.8-bar) maximum allowable working pressure (MAWP) cylinder normally operated with a maximum discharge pressure of 4200 psig (289.6 bar). An extensive metallurgical analysis revealed that the cylinder had several cracks that had originated in the seating ledge radii in both the head and crank end discharge valves. Over time, the cracks had propagated, finally reaching the other wall, creating a leak near an indicator valve connection.

Inspection of the other 18 cylinders at the facility revealed that five had internal cracks near the discharge valve seating ledges. Although this find was alarming, it was somewhat of a conundrum that 13 of the 19 cylinders that operated under identical conditions were crack-free. With six decades of operation within design operating conditions and nearly 100,000 hours of operation at design speeds of 330 rpm, the cylinders had accumulated approximately 2×10^9 stress cycles. This long successful history essentially dispelled any notion of high-cycle fatigue as the cause of crack initiation. However, once cracks are initiated, fatigue could certainly drive crack

Figure 1. Second-stage cylinders similar to the type that failed on a 330-rpm integral engine-compressor are shown.

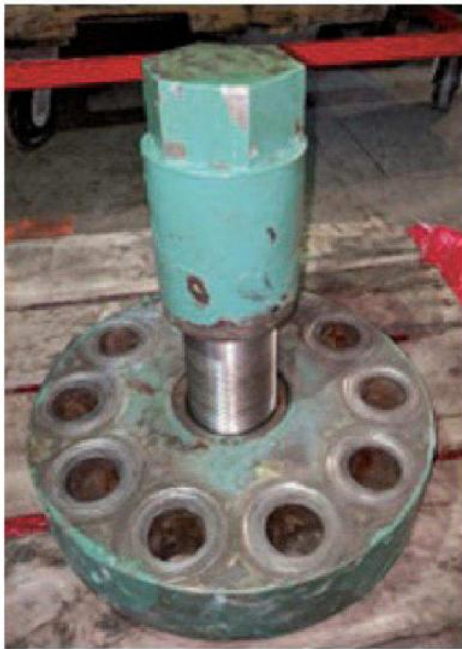
As shown in Figures 1 and 2, the cylinder valve caps were retained by nuts tightened onto ten 1.5-in.- (38.1-mm-) diameter studs. A 3-in.- (76.2-mm-) diameter jack bolt in the cap was used to hold the valve against the seat in the valve pocket. A large cap on the jack bolt was tightened against a metal gasket to prevent leakage around the jack bolt threads to atmosphere.

Figure 2. A 3-in. (76.2-mm) jack bolt in the valve cap was used to hold the valve against the seat in the valve pocket. A large cap on the jack bolt was tightened against a metal gasket to prevent leakage around the jack bolt threads to atmosphere.

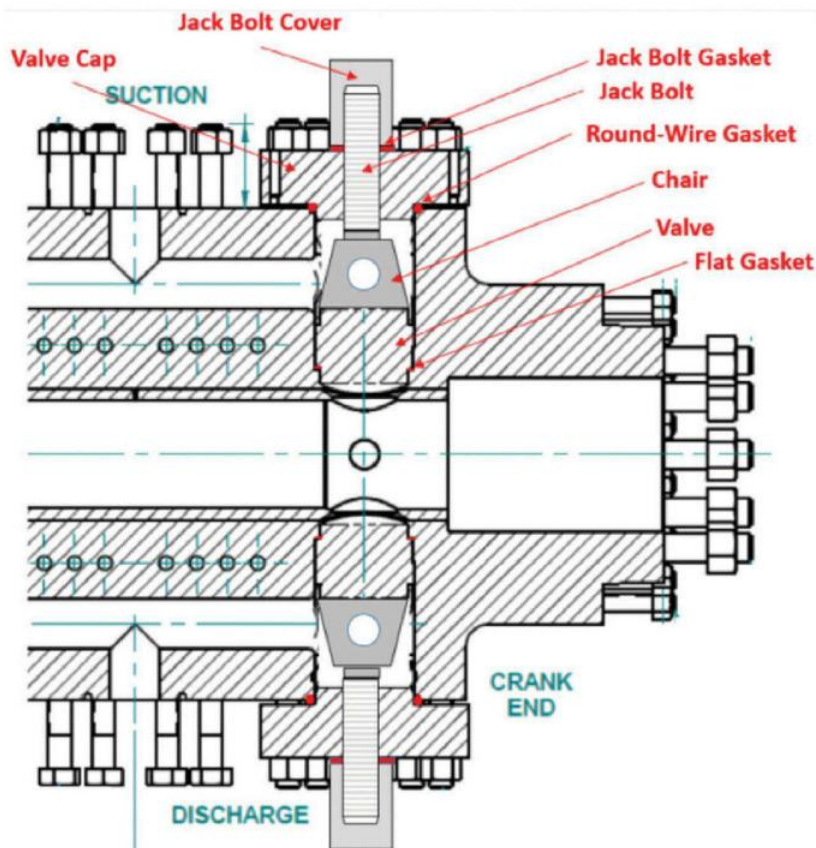
Figure 3 shows a cross section of the valve and cap assembly. The valve cap bolting provided the force needed to crush a round-wire steel gasket between the cap and the outer edge of the valve pocket bore in the cylinder to accomplish primary gas sealing between the

cap and cylinder. The jack bolt was intended to provide the force necessary to crush the flat steel gasket under the valve at the valve pocket seating ledge. Both the valve cap bolting and the jack bolt had to provide the necessary preload to crush the metal gaskets for sealing. In addition, the valve cap bolting had to resist the hydrostatic pressure load on the underside of the valve cap.

Figure 3. Cross section of the valve and cap assembly on the original cylinders. The valve cap bolting provided the force needed to crush a round-wire steel gasket between the cap and the outer edge of the valve pocket bore in the cylinder to accomplish primary gas sealing between the cap and the cylinder. The jack bolt was intended to provide the force necessary to crush the flat steel gasket under the valve at the valve pocket seating ledge. Both the valve cap bolting and the jack bolt had to provide the necessary preload to crush the metal gaskets for sealing; in addition, the valve cap bolting had to resist the hydrostatic pressure load on the underside of the valve cap.

the round wire gaskets or to avoid internal knocking from loose valve assemblies. In any event, there was a lot of uncertainty about the magnitude of the assembly load applied to the valve caps and the valve seats over 60 years of service. The required bolt loads were calculated, and historical records indicated that the maximum cylinder discharge pressures were 4230 psig (291.7 bar), about 85% of the cylinder maximum pressure rating. The rectangular-shaped cylinder was carefully measured, and a 3D computer-aided design (CAD) model was generated. The CAD model was used to conduct extensive finite element analyses (FEA) that considered assembly loads, thermal loads, and static and cyclic pressure loads. FEA studies confirmed that the peak stresses coincided at the exact location of the crack origin as determined from the metallurgical investigation.

Although the FEA confirmed the crack initiation point at the edge of the 1/16-in. (1.6-mm) fillet radius at the discharge valve seating ledge, the high magnitude of the stress predicted from the assembly loads was very troubling. The FEA analysis did not consider nonlinear effects (i.e., yielding), and the calculated peak stress from the valve cap and jack bolt assembly was more than twice the yield strength of the material. So, these FEA results were not realistic, because once the local stress reached the material yield strength, yielding (i.e., plastic deformation) would

occur. A small amount of local yielding is not necessarily a concern, but the wide area of predicted high stresses in this case indicated that there would be substantial material yielding in the valve seat fillets caused by the normal assembly loads on the bolting. This very high local plastic strain throughout the valve seat fillet would be repeated every time the valve caps and/or the valve cap jack bolts were tightened. Although the stress magnitude might be limited by plastic deformation, the high plastic strain magnitude over several cycles led to the theory that low-cycle fatigue was the likely source of crack initiation and failure.

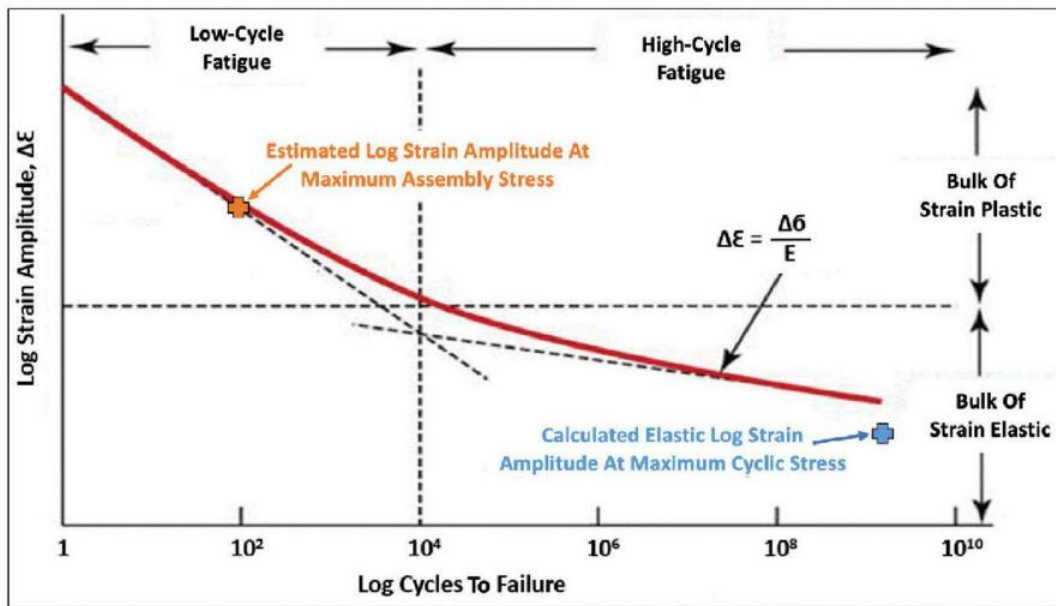
Low-cycle fatigue is characterized by a high strain amplitude and a low number of cycles, as shown in Figure 4.² The low-cycle fatigue regime is characterized, very arbitrarily, as the range from one to 10,000 cycles. The actual range depends on the material's properties. It is the point where most of the cyclic strain is plastic rather than elastic. As depicted in Figure 4, low-cycle fatigue failure can occur in just a few cycles if the cyclic strain is high enough. In the case of low-cycle fatigue, stress produces both elastic and plastic strains, but the bulk of the strain is plastic.³ This is particularly important in areas with geometric discontinuities or stress risers. As a result of the plastic deformation in low-cycle fatigue, failure occurs in a reduced number of cycles compared to high-cycle fatigue failure.

Figure 4. Representation of strain amplitude vs. cycles to failure showing low-cycle and high-cycle fatigue regimes. The strain amplitude that resulted from the calculated cyclic stress amplitude during the compressor operation in this case is shown symbolically by the blue cross at 2×10^9 cycles, well below the failure line. The loading during the valve cap assembly process resulted in a strain shown symbolically by the orange cross at 1×10^2 cycles, reaching or exceeding the low-cycle fatigue limit.

In Figure 4, the blue cross at 2×10^9 cycles represents the calculated strain amplitude that resulted from the calculated cyclic stress amplitude during the compressor operation. The cyclic strain during normal compressor operation is substantially less than the yield strength and therefore entirely elastic. Since it is also well below the failure line, high-cycle fatigue failure is not likely. However, the loading during the valve cap assembly process resulted in a strain shown symbolically by

the orange cross at 1×10^2 cycles in Figure 4. The actual strain (which is mostly plastic) and the number of cycles was not known. However, each time the valve cap was assembled, the high plastic strain was repeated, eventually reaching the low-cycle fatigue limit that would initiate a crack. Over many years and many dozens of cylinder valve cap assembly events, even if detailed assembly specifications had been provided and adhered to, the loading on these legacy cylinders was such that low-cycle fatigue became a serious concern.

Since the high valve cap and jack bolt assembly loads caused very high plastic strains in the valve seat fillets, by inference from Figure 4, it would take a relatively small number of cycles to initiate a crack. Once a crack started, additional assembly events over time would propagate the crack, as would normal high-cycle fatigue from the cyclic internal pressure that occurs with each piston stroke. As the crack propagated, the section would become weaker and the rate of propagation would increase. Discussions with the station operator indicated that individual valve caps could have been installed and the bolting tightened somewhere in the range of 60 to 120 times over the 60-year operating span before the gas leak was detected. Some valve caps would have been assembled more than others, and with the uncertainty about the assembly procedures and bolt torquing that was applied, the low-cycle fatigue theory reasonably explained why the cylinders had performed reliably for so many years, and why some were now developing cracks.

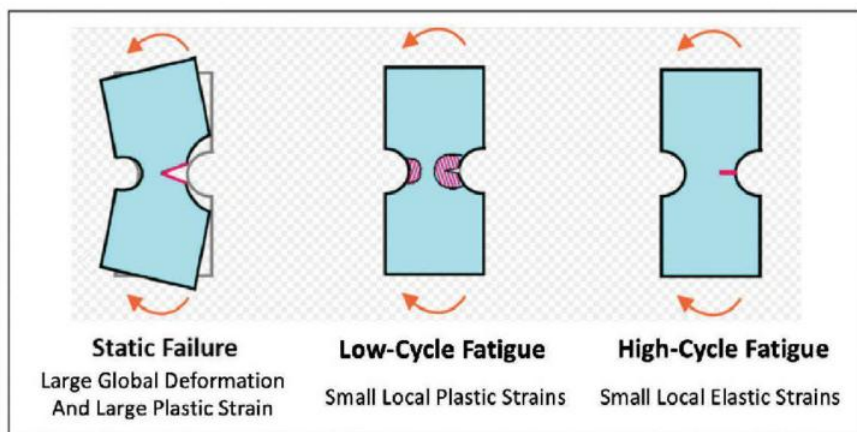
Figure 5 is useful for explaining the differences in failure mechanisms. In the left image, static failure can be produced by one cycle of high loading that causes large global deformation and a very large plastic strain. Since only six of 19 cylinders had cracks in the valve seats, especially considering their long period of service, static failure was improbable as the cause of crack initiation. In the right image in Figure 5, high-cycle fatigue results in small local elastic strains, which, if high enough, can initiate a surface crack that is then propagated over time. As explained earlier, the fact that these cylinders had about 2×10^9 stress cycles (two orders of magnitude above the typical material endurance limit) before any cracks became evident made high-cycle fatigue improbable as the cause of crack initiation. In the middle image of Figure 5, the case of low-cycle fatigue is characterized by local plastic strains that will eventually initiate a crack. Loads that increase the mean stress above the yield stress

produce failure by yielding rather than by fatigue, and classical fatigue analysis becomes inapplicable.⁵

Figure 5. Differences in common failure mechanisms. (Left) Static failure can be produced by one cycle of high loading that causes large global deformation and a very large plastic strain. (Right) High-cycle fatigue results in small local elastic strains, which, if high enough, can initiate a surface crack that is then propagated over time. (Middle) The case of low-cycle fatigue is characterized by local plastic strains that will eventually initiate a crack.

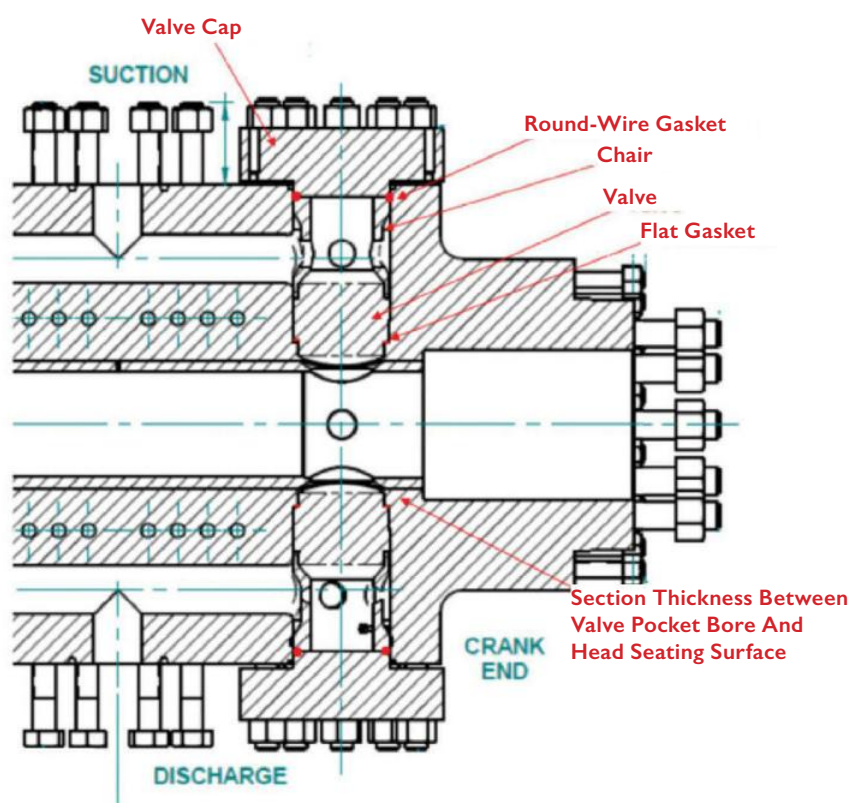
Figure 6. To resolve the problem, new cylinders were designed to eliminate the valve cap jack bolts. Because of the high operating pressure and concern about the reliability of elastomeric O-ring seals in this case, it was necessary to retain metal seals for the valve caps as well as the valve seats. Accordingly, the cylinder design had to be significantly improved to eliminate its susceptibility to low-cycle fatigue, including tolerance for uncertainties in metal gasket hardness and assembly procedures over time. The most important improvement was upgrading the cylinder body material to increase the yield strength. Other significant changes included increasing the valve seating ledge fillet radius and increasing the cylinder width to reduce the secondary effects of the cylinder head assembly loads on the valve pockets.

To resolve the problem, new cylinders were designed to eliminate the jack bolts as shown in Figure 6. Because of the high operating pressure and concern about the reliability of elastomeric O-ring seals in this case, it was necessary to retain metal seals for the valve caps as well as the valve seats. Accordingly, the cylinder design had to be significantly improved to eliminate its susceptibility to low-cycle fatigue, including tolerance for uncertainties in metal gasket hardness and assembly procedures over time. The most important improvement was upgrading the cylinder body material to increase the yield strength by 89%, from 55,600 to 105,000 psi (3833 to 7239 bar). In addition, the valve seating ledge fillet radius was increased to $\frac{1}{4}$ in. (6.4 mm) to reduce the stress concentration, and the cylinder width was increased by 20% to reduce the secondary effects of the cylinder head assembly loads on the valve pockets. FEA studies of the new cylinder design showed that the valve cap assembly stress was 63% of the new material's yield strength. It was still higher than the original material yield strength, which dictated the upgrade to the stronger material. The new cylinders were designed to replace the original cylinders without changing pipe connections or mounting.
